# EQUIPMENT DATA SHEET

Unit Designation: Isotope Exhaust Fan (EU-19-003-1)

# PREDICTIVE MAINTENANCE PROGRAM

## Start-up Analysis

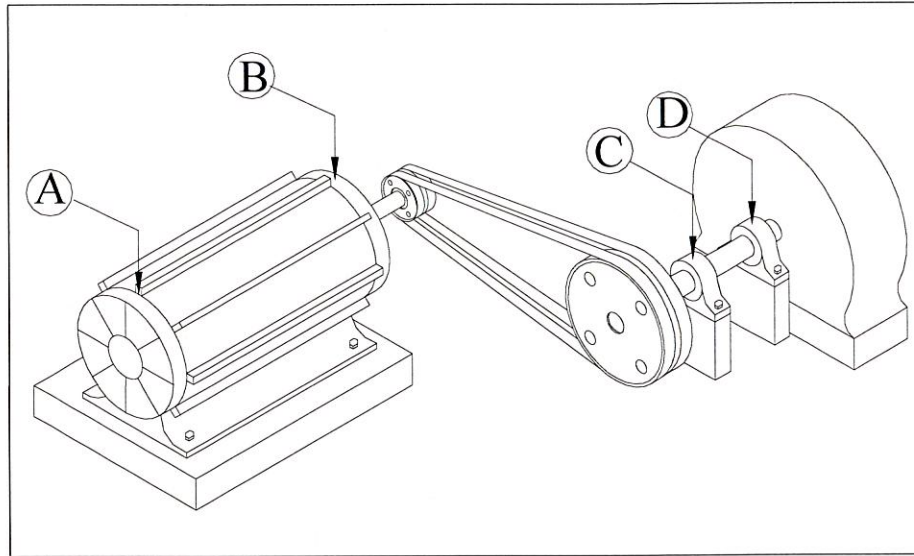
The overall vibration levels are excessive due to worn belts, misaligned sheaves, and fan unbalance. Our visual inspection revealed that two of three belts are worn and cracked, the motor sheave is badly worn due to improperly tensioned belts, and the sheaves are misaligned.

Our spectral analysis indicates both motor bearings lack lubrication and show slight to moderate wear. However, they are both sealed and cannot be re-lubricated; further monitoring is required to determine the rate of deterioration and appropriate timing for replacement.

Both fan bearings are in good condition and adequately lubricated.

Our belt drive analysis indicates this unit is under-belted with the use of 5V belts. The situation is easily corrected however, by specifying 5VX belts at the next replacement.

- 5 Replace the motor sheave immediately.
- 5 Replace the belts with 5VX Opti-Belts (or another premium belt) immediately.  
Accurately align the sheaves and set the belt tension to the minimum level required to avoid slippage on start-up.
- 4 Have the fan balanced following the belt and sheave change (if you need assistance, Vibtech offers on-site balancing).
