DESCRIPTION	DATE
Fuses	Nov. 21, 2016

Identification: CV 087, Section A-70

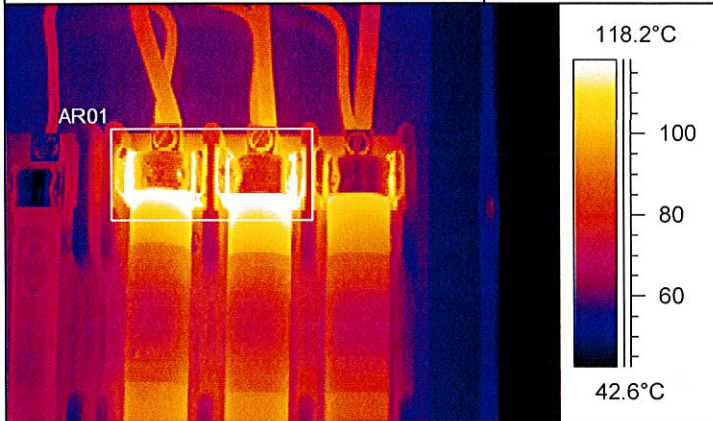
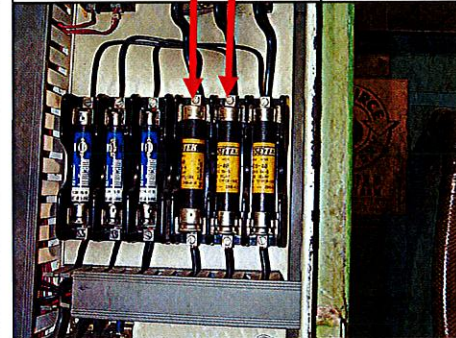
IR information	Value
Date of creation	11-21-2001
Object parameter	Value
Ambient temperature	22.0°C
Label	Value
AR01 : max	146.6°C

An InfraRed image of fuses located inside the CV 087 panel; identified as the main fuses. Heating was noted on the top-middle/ left fuse clip connections (red arrow in photo). See IR information chart above for maximum temperature inside area box. *An Immediate Action Report was issued for this anomaly at the time of the inspection.*

Check the connection components for heat damage. Replace if required.
Clean the fuse and fuse clips. Ensure the fuse clip tightness as per the manufacturer's specifications.
Re-inspect the unit after the repairs are completed.
